# NATIONAL TRANSPORTATION SAFETY BOARD

## MATERIALS LABORATORY FACTUAL REPORT

Report No. 13-092

Place : San Francisco, California  
Date : July 6, 2013  
Vehicle : Boeing 777-200ER  
NTSB No. : DCA13MA120  
Investigator : Peter Wentz

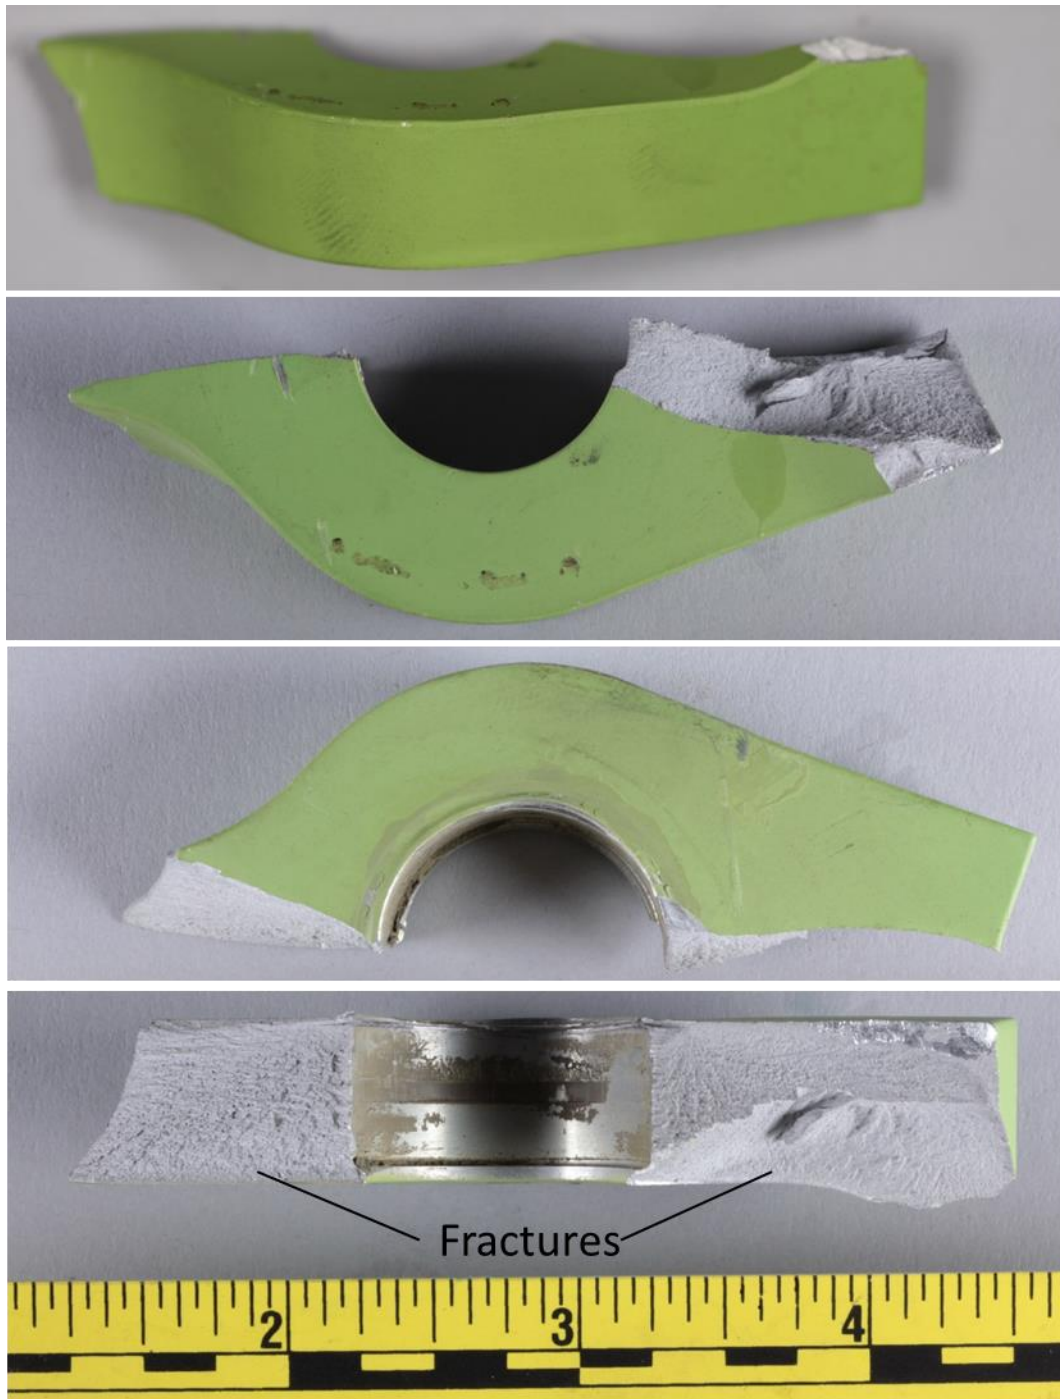
Images of the piece of the vertical tie rod attach are shown in Figure 1. Higher magnification macrographs of the fracture surfaces are shown in Figure 2. Fractographic analysis reveals river patterns indicating that both fractures initiated at the periphery of the hole on one side of the piece and propagated through the thickness in a manner consistent with cantilever bending. Examination under a 5X to 50X stereo zoom microscope revealed fractographic features consistent with overstress loading. No preexisting damage such as a fatigue crack was observed.

Figure 1 Views of the piece of overhead bin vertical tie rod attach. The fracture surfaces are identified in the lower-most image.

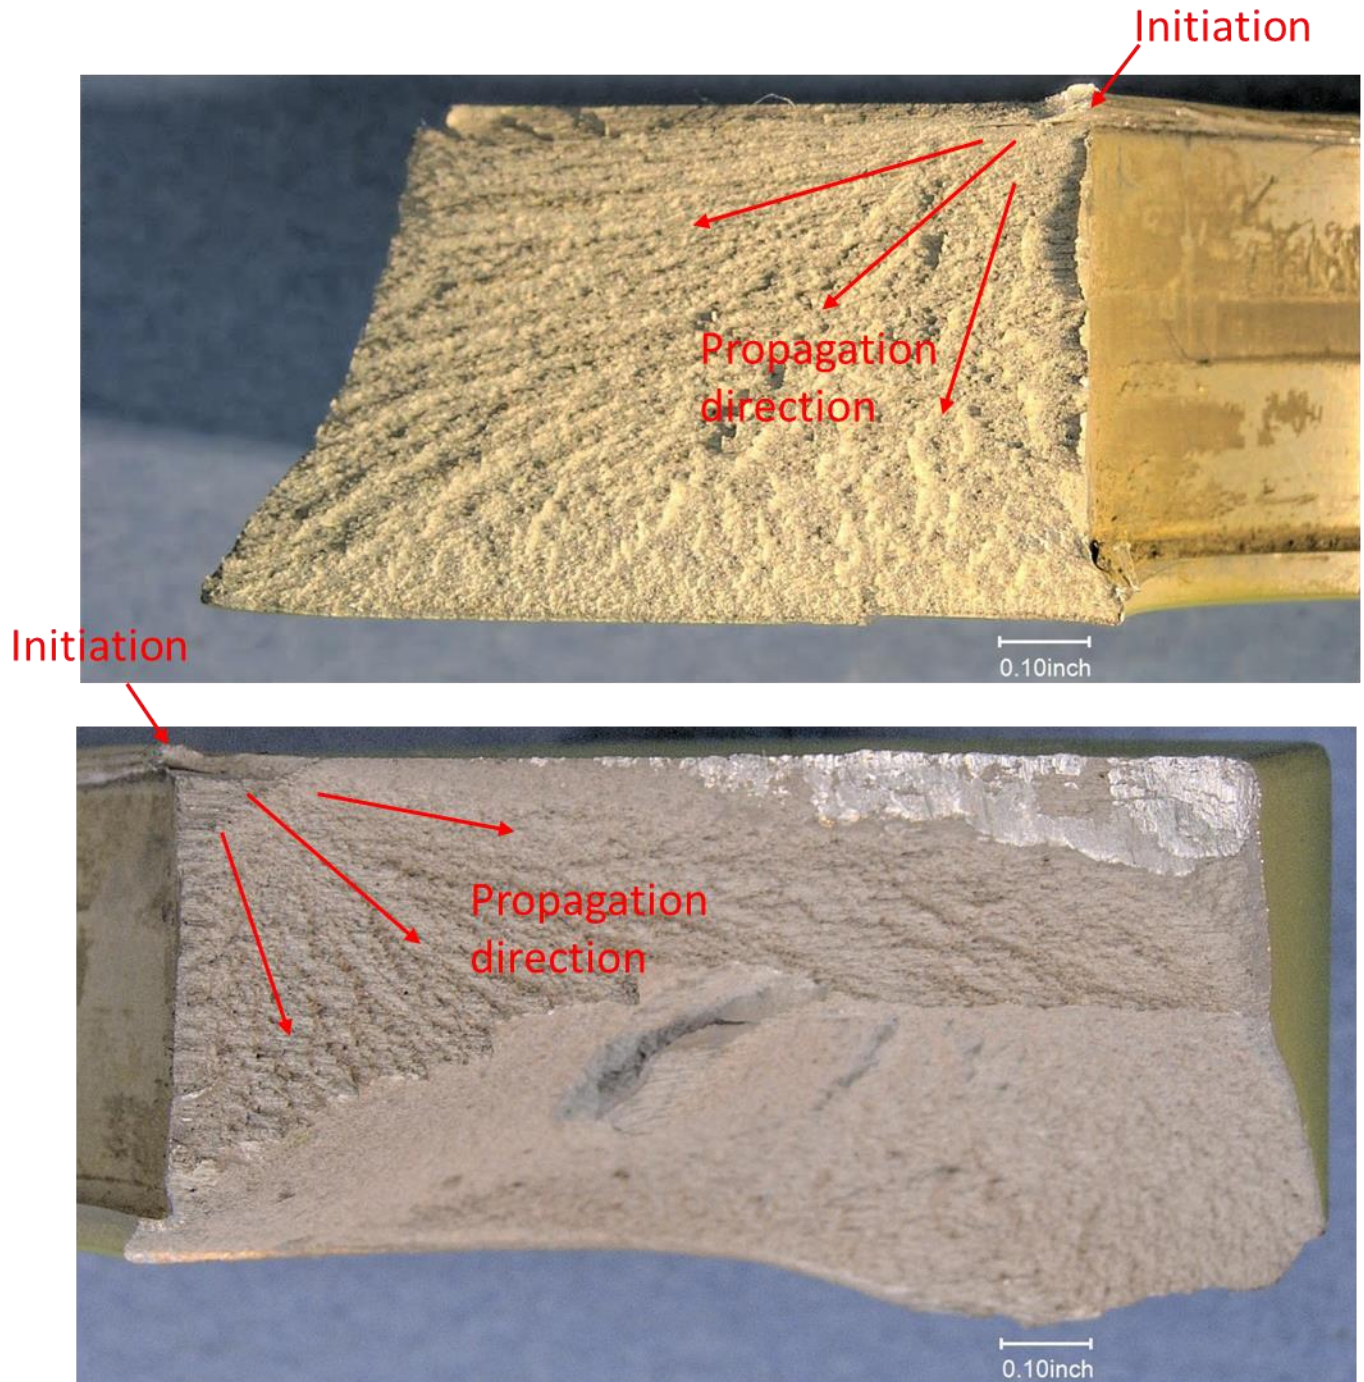
Figure 2 Higher magnification images of the fracture surfaces on the piece of overhead bin vertical tie rod attach. The areas of fracture initiation and crack propagation direction are indicated in the images.

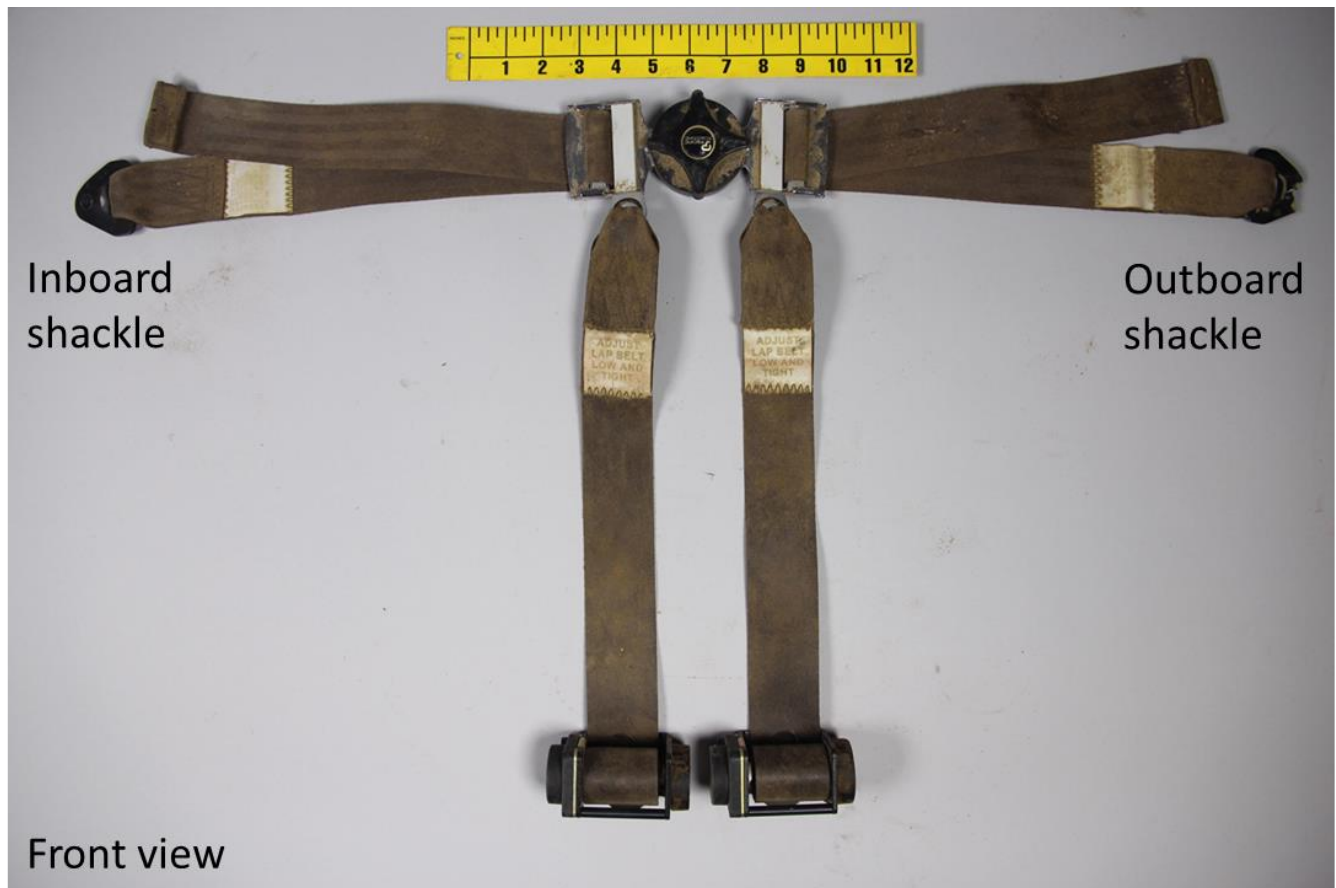
Front and back views of the M4A attendant jump seat restraint harness are shown in Figures 3 and 4, respectively. Visual inspection revealed both lap belt shackles (fabricated from anodized aluminum alloy) to be damaged. The inboard shackle was bent in a manner consistent with the application of a tension force in the webbing at a vector ranging to about 45° from the major axis of the shackle away from the seat. As shown in Figure 5b about 5% of the black anodic coating spalled from the surface along the compression side of the axes of bending.

Figure 3 Image of the front view of the M4A attendant jump seat restraint harness.

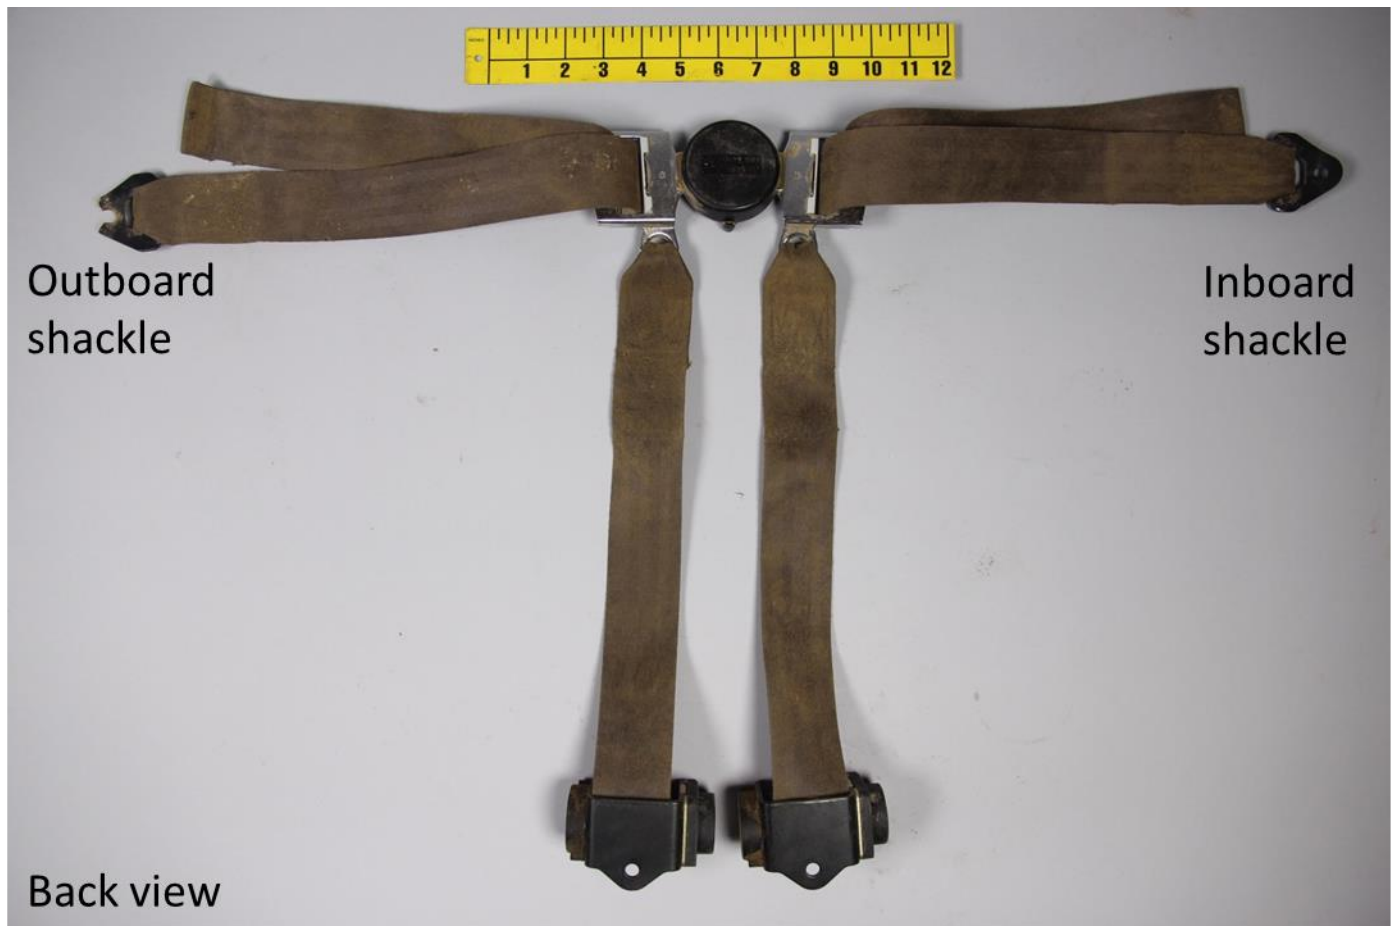
Figure 4 Image of the back view of the M4A attendant jump seat restraint harness.

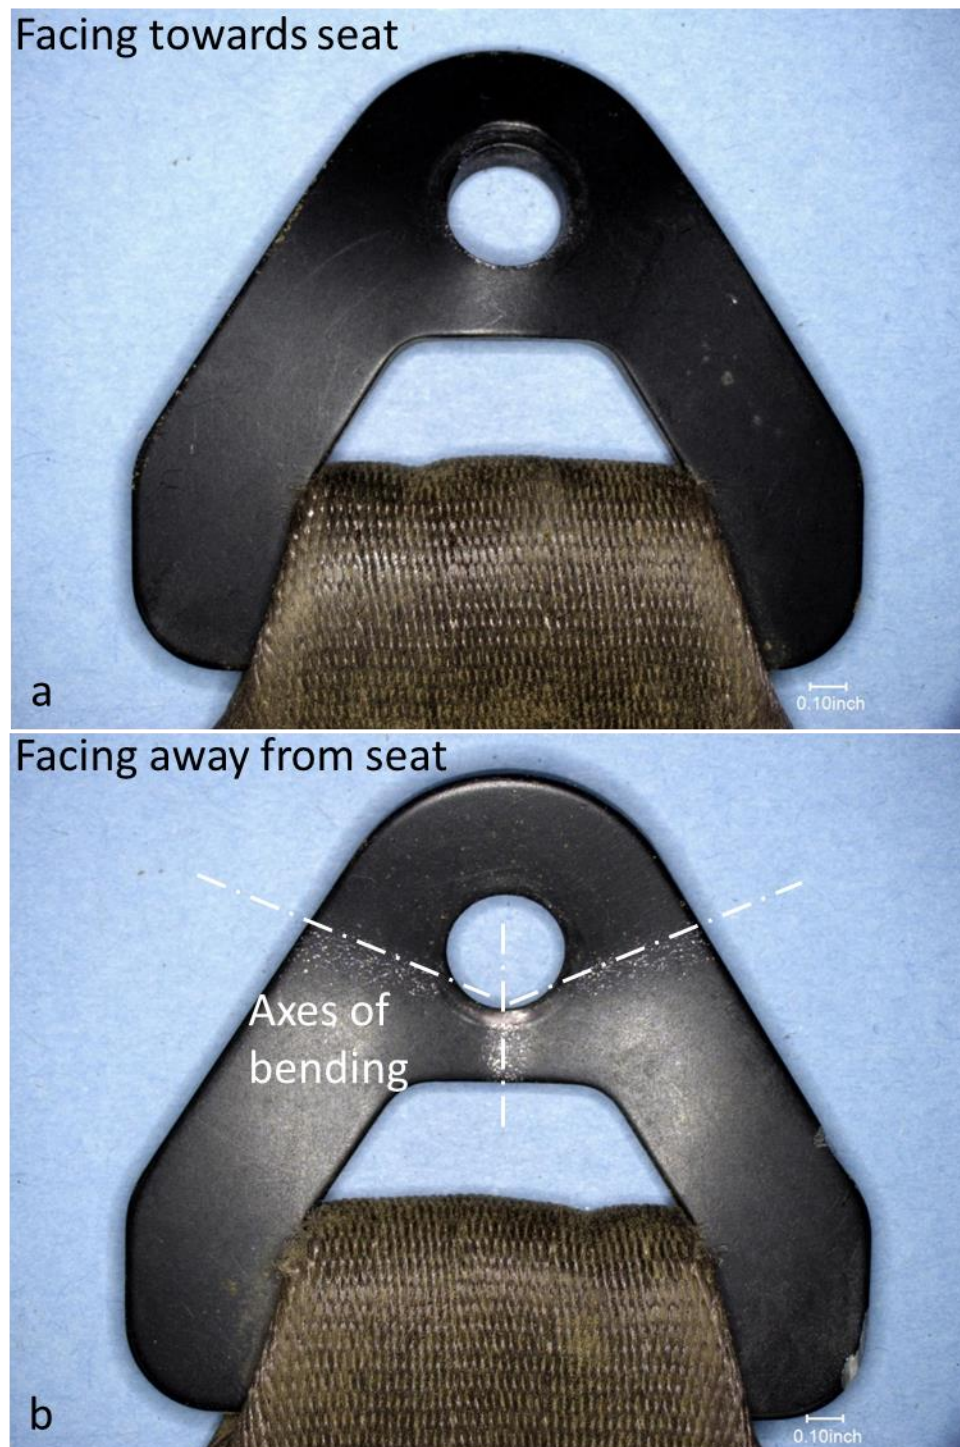
Figure 5 Images of the inboard shackle on the lap belt of the M4A attendant jump seat restraint harness.

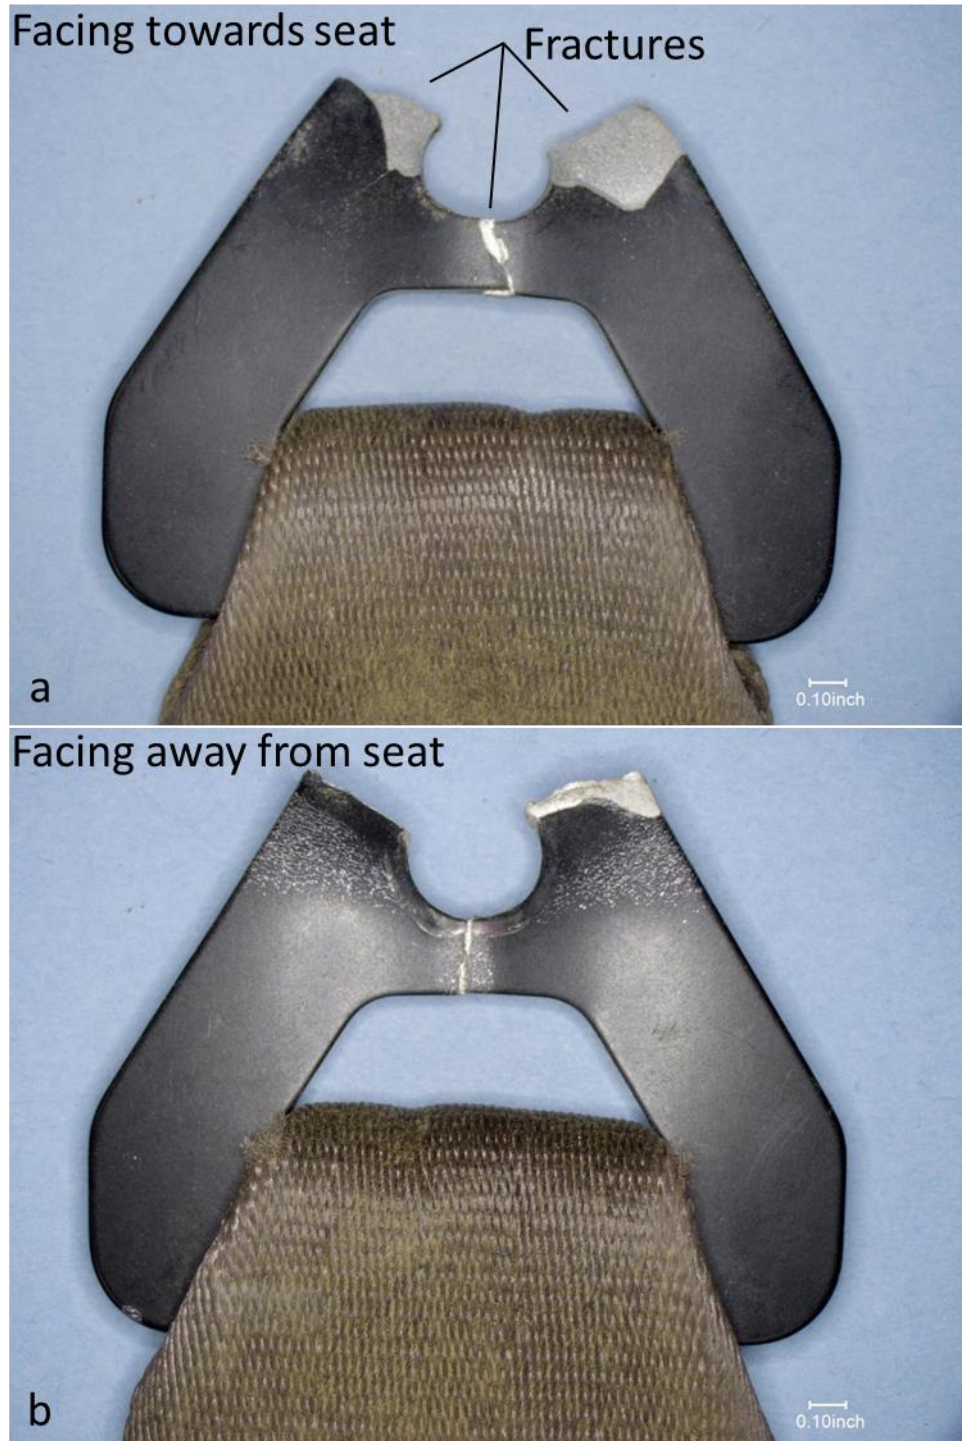
The outboard shackle was bent in a manner consistent with the application of a tension force in the webbing at a vector ranging to about 45° from the major axis of the shackle away from the seat. The axes of bending are similar to that noted in Figure 5b. As revealed in Figure 6a, the shackle fractured in three places. Examination under a 5X to 50X stereo zoom microscope, indicates that the fracture features are consistent with

combined tension and bending overstress loading. Observed in Figure 6b, about 5% of the black anodic coating spalled from the surface along the compression side of the axes of bending. No preexisting damage such as a fatigue crack was observed.

Figure 6 Images of the outboard shackle on the lap belt of the M4A attendant jump seat restraint harness.
